Case study

An investigation into failure analysis of interfering part of a steam turbine journal bearing

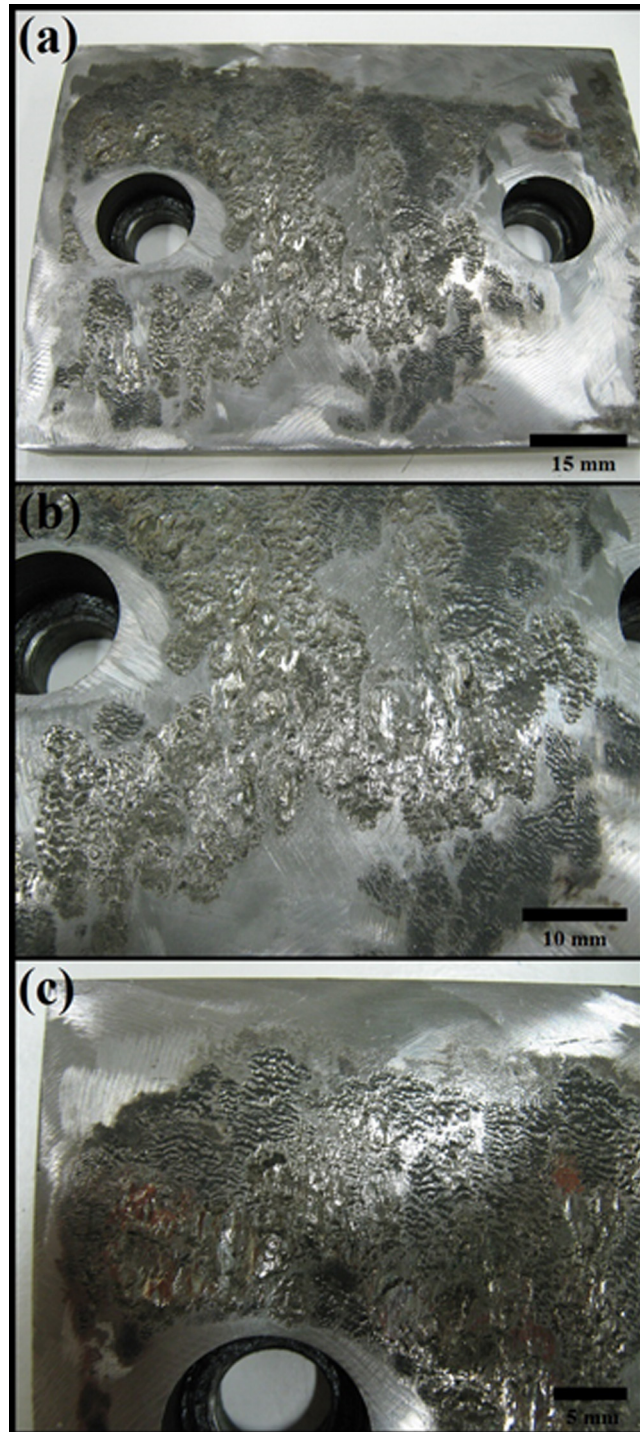
Fig. 2. Macro images of failed interfering part of turbine journal bearing.

Low magnified electronic macro images represent the failed surface of interfering part of journal bearing is demonstrated in Fig. 2. The overall view of surface area revealed that it was totally subjected to a phenomenon such as cyclic crushing with relatively deep holes in some regions. Surface of this dished area seems approximately shiny near to polish. Also, surface partially covered by some brown substances which were the result of low carbon steel oxidation or oily inclusions. Also, the close view showed that there are some deformation paths and crushed zones at this area. The magnified appearance of this deformed surface is shown in Fig. 3. These stereographic micro images illustrate some small regular features related to wear paths.

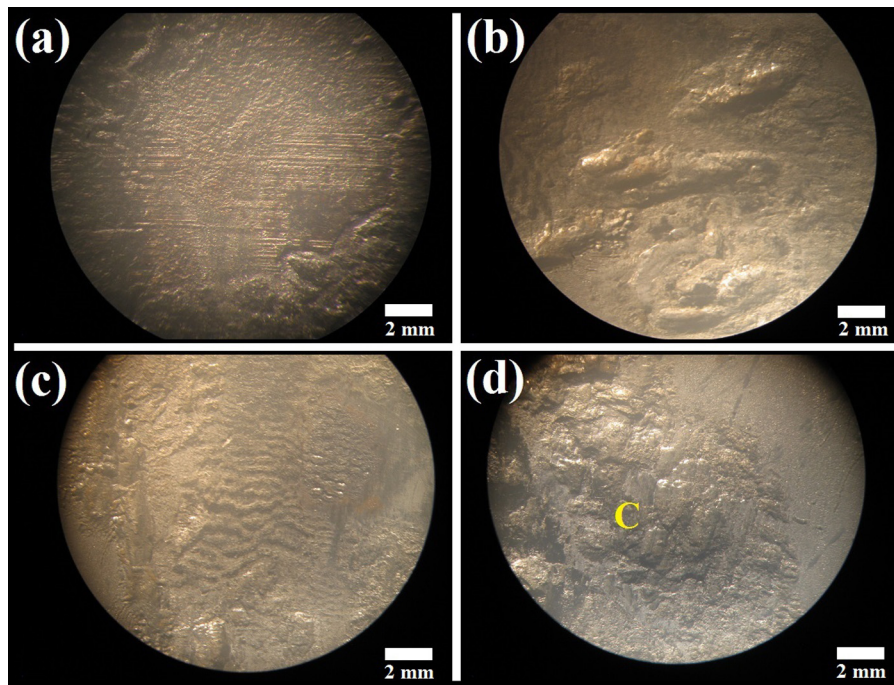
Fig. 3. Stereographic macro images of failed sample surface.

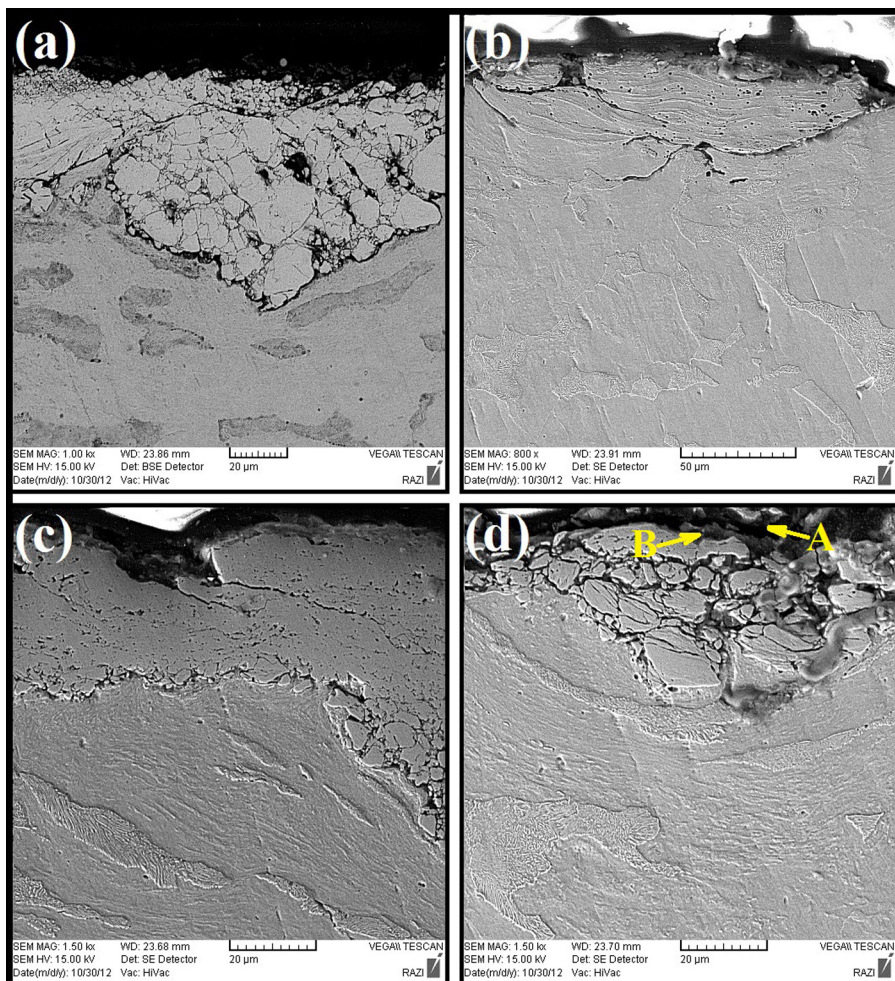
Fig. 5. The SEM microstructures of failed sample cross section.

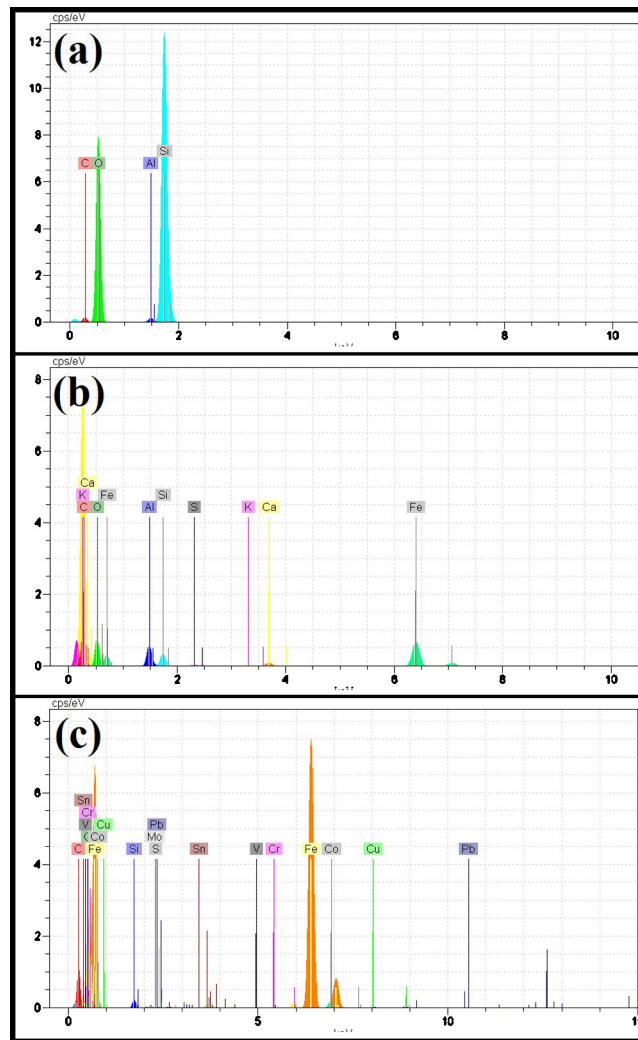
Fig. 6. The EDS analysis spectra correspond to (a) A, (b) B and (c) C scan points, respectively.

Chemical composition of points (a) A, (b) B and (c) C, obtained from EDS analysis. High carbon contents in these analysis results are corresponding to contaminations or journal bearing oil.
